UTILITY DETECTION IN CONCRETE STRUCTURES BY 3D SCANS USING GROUND PENETRATING RADAR

Ranjit Singh Dharam Singh & Loh Yuliang
Infrastructure University Kuala Lumpur, MALAYSIA

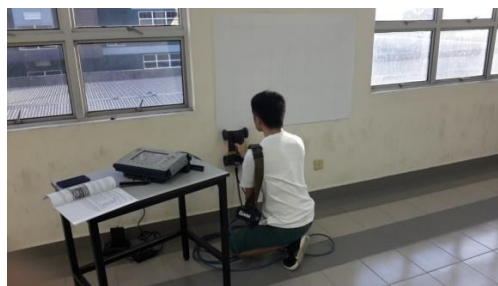
Figure 3: GPR Scanning On Area 1 (Wall)

Six areas have been selected to perform the structural scan using GPR at Block 9, Infrastructure University Kuala Lumpur (refer to Figure 3 to Figure 8). The grid line used in this study has a dimension of 15 cm x 15 cm with a length of 90 cm and a width of 75 cm. The GPR will start the data collection on the x-axis followed by the y-axis. The GPR must be moved slowly in a straight line on the x-axis and y-axis.

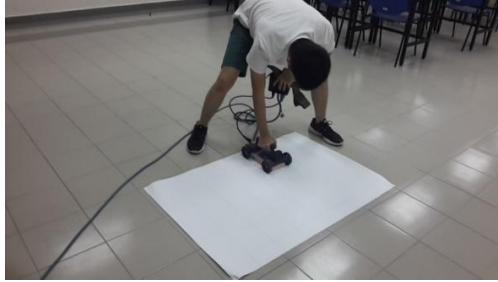
Figure 4: GPR Scanning On Area 2 (Floor)

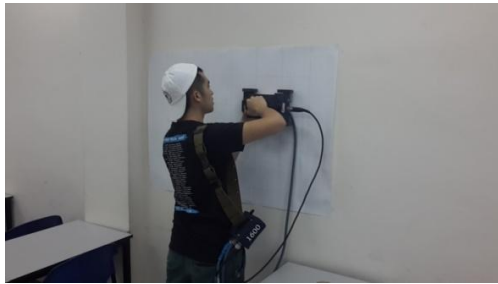
Figure 5: GPR Scanning On Area 3 (Wall)

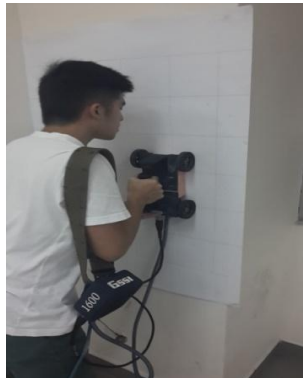
Figure 6: GPR Scanning On Area 4 (Column)

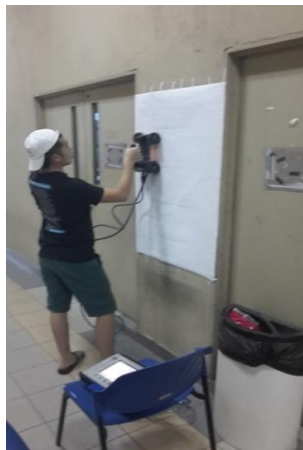
Figure 7: GPR Scanning On Area 5 (Column)

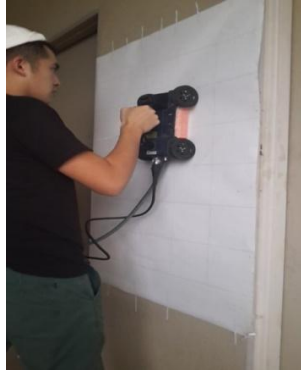
Figure 8: GPR Scanning On Area 6 (Column)

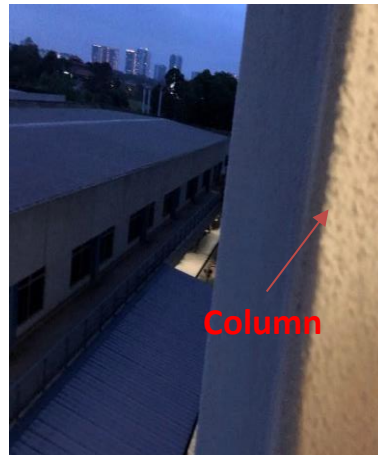
Figure 10: Column Behind the Wall

The result of the GPR scan in 3D for Area 1 (wall) is shown in Figure 9. The GPR scan data shows three hyperbolas in the vertical direction. The hyperbolas represent the detected utilities inside the wall which are the rebars. The diameter of the rebars is about 30mm. Further checking reveals that there is a column located behind the wall (Figure 10). The rebars are only detected in the area where the column is located. As can be seen in Figure 9 only vertical rebars are available in the column.

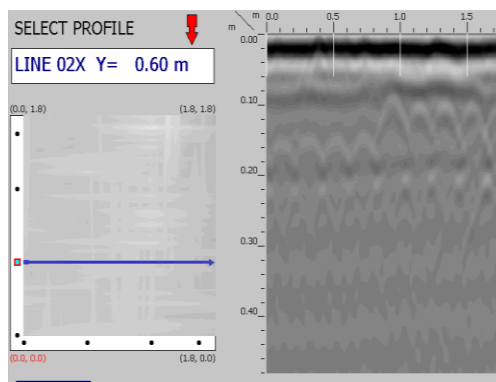
Figure 11 shows the result of GPR scan in 3D for Area 2 (floor). As can be seen from the 3D scan there is no utility detected in Area 2.

Figure 11: 3D Scan of Area 2

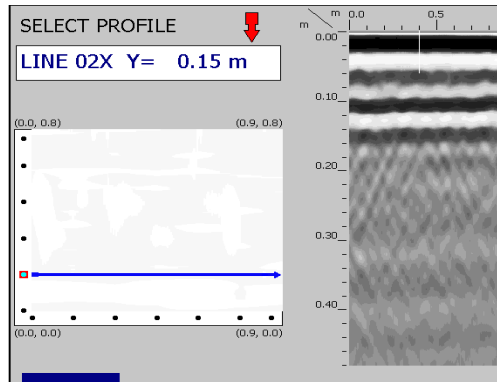
Figure 13 shows the result of the GPR scan in 3D for Area 4 (column). There is no utility detected in Area 4 as shown in the 3D scan. There is no visible hyperbola in the 3D scan. It can be assumed that this area is near the edge of the column and the rebars in the column should be in the centre of Area 4 which cannot be accessed by the GPR as it is sealed off by a wall.

Figure 13: 3D Scan Of Area 4

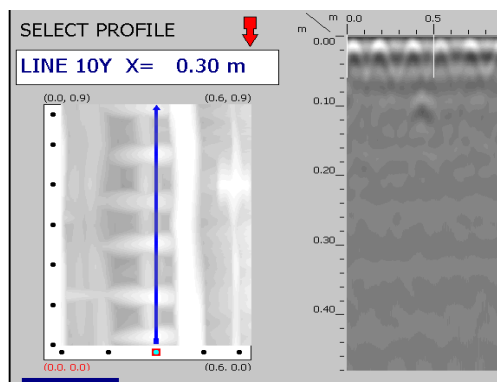
Figure 16 and Figure 17 show the results of the GPR scan in 3D for Area 6 (column). It can be noticed from the 3D scan that the distance between the vertical rebar is not consistent and the depth of the vertical rebar is not the same. This condition is the same as Area 5 (Figure 14 and Figure 15). It can be presumed that Area 5 and Area 6 have the same structural mechanism since the distance between these two columns is about 20m apart.

Figure 17: 3D Scan Of Area 6 Showing The Horizontal Rebars
